INDOOR AIR QUALITY ASSESSMENT

**Johnson Elementary School
290 Castle Road
Nahant, Massachusetts**

Prepared by:
Massachusetts Department of Public Health
Bureau of Environmental Health Assessment
March, 2001

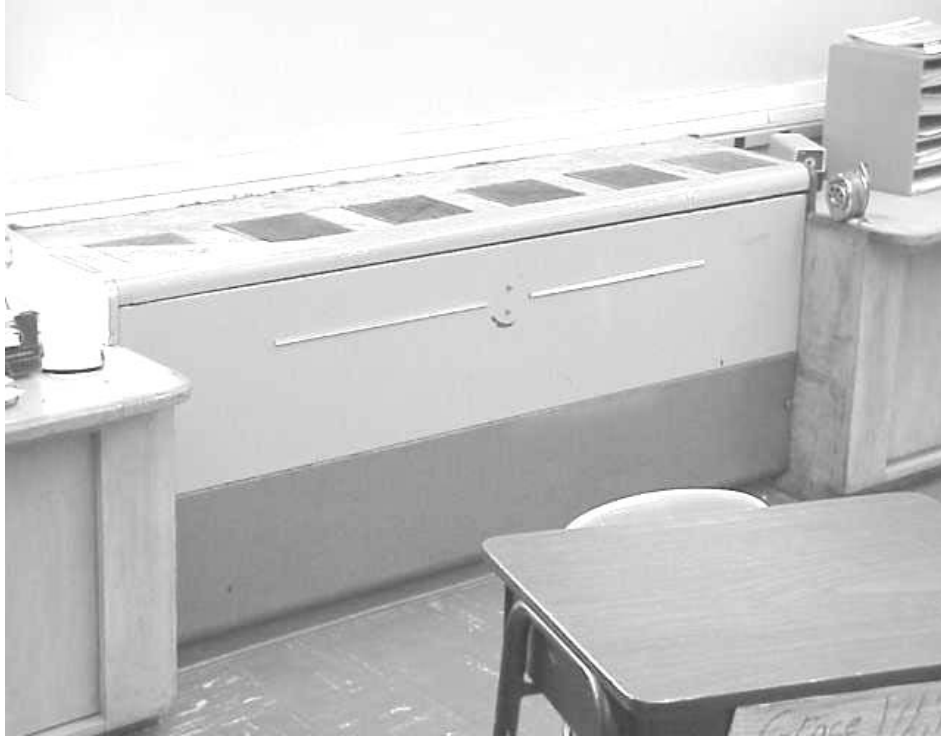
Picture 1

Fresh air in classrooms is supplied by a unit ventilator (univent) system (see Picture 1). Univents draw air from outdoors through a fresh air intake located on the exterior walls of the building (see Picture 2) and return air through an air intake located at the base of each unit ([see Figure 1](#)). Fresh air and return air are mixed, filtered, heated and provided to classrooms through a fresh air diffuser located in the top of the unit. Mr. LaValley reported that outside air intakes had been sealed with plywood for a number of years as an energy conservation measure. Obstructions to outside air intakes were removed during the summer of 2000 and a heating, ventilating and air conditioning (HVAC) engineering firm was hired to assess univents and make to repairs. According to Mr. La Valley a number of air intake actuators were disconnected, which were re-

Classroom Univent

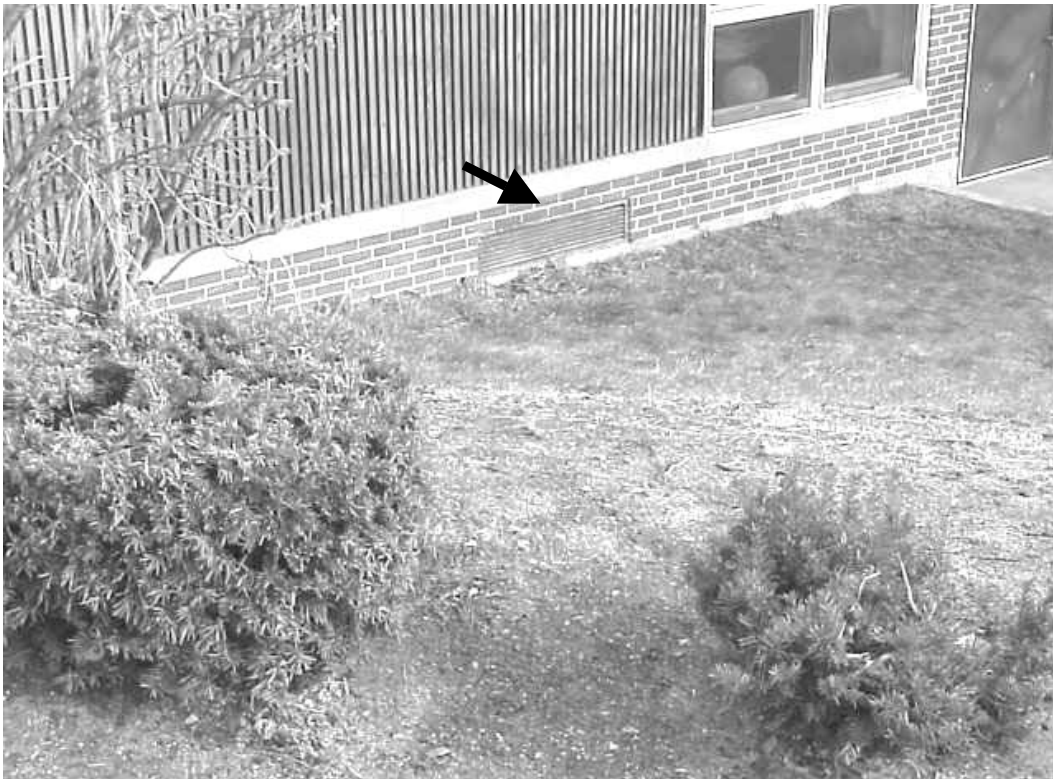
Picture 2

Along the perimeter of the building, some of the univent fresh air intakes are located at ground level (see Picture 1). Care should be taken to ensure that fresh air intakes remain clear of obstructions (e.g., snow, shrubbery) to avoid the entrainment of dirt, moisture and or pollen.

Univent Outside Air Intake, Note Location to Ground

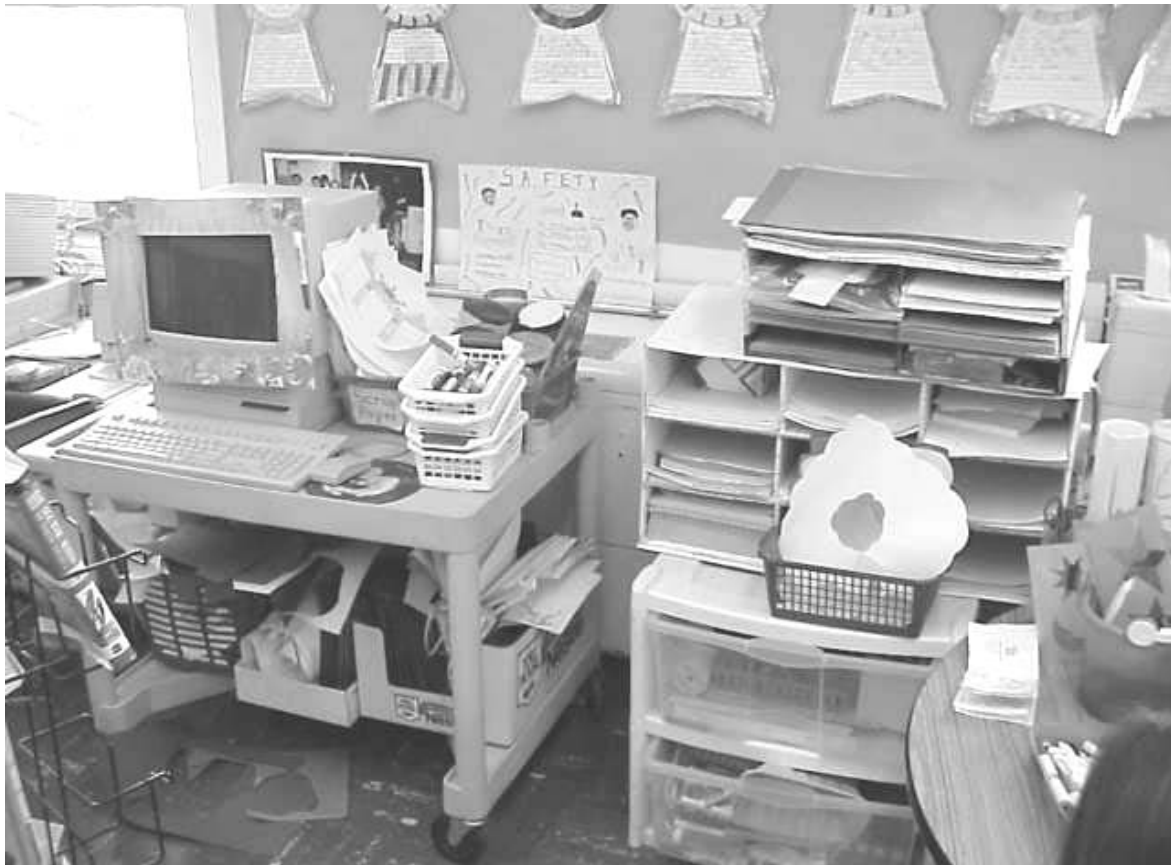
Picture 3

Obstructions to airflow, such as books, papers and posters on top of univents, and bookcases, tables and desks in front of univent returns were also seen in a number of classrooms (see Picture 3). To function as designed, univent fresh air diffusers and return vents must remain free of obstructions. It is important that these units be activated and allowed to operate during school hours.

Univent Obstructed by Various Items

4. Reactivate restroom exhaust ventilation to remove excess moisture and odors.
5. Remove all blockages from univent fresh air diffusers, return vents and exhaust vents to facilitate airflow.

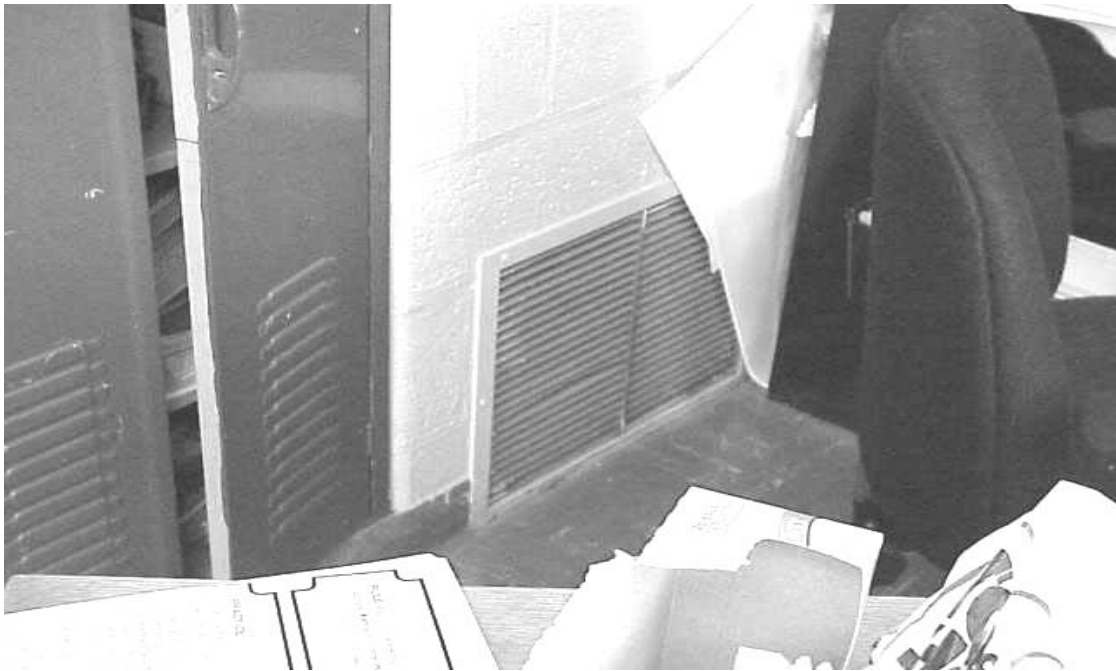
Picture 4

The mechanical exhaust ventilation system in each classroom consists of ducted, grated wall vents powered by rooftop exhaust motors (see Pictures 4 & 5). Mr. LaValley reported that the schools exhaust system had been deactivated for approximately ten years. Some rooftop exhaust motors were reactivated, some of them irreparable. BEHA staff found these vents deactivated and backdrafting in a number of classrooms, indicating exhaust motors were off or non-functional. As with the univents, a number of exhaust vents were obstructed by tables, chairs, boxes and other items (see Picture 6). No exhaust ventilation could be identified in the library. Without adequate exhaust ventilation, excess heat and environmental pollutants can build up and lead to indoor air complaints.

Wall-Mounted Exhaust Vent

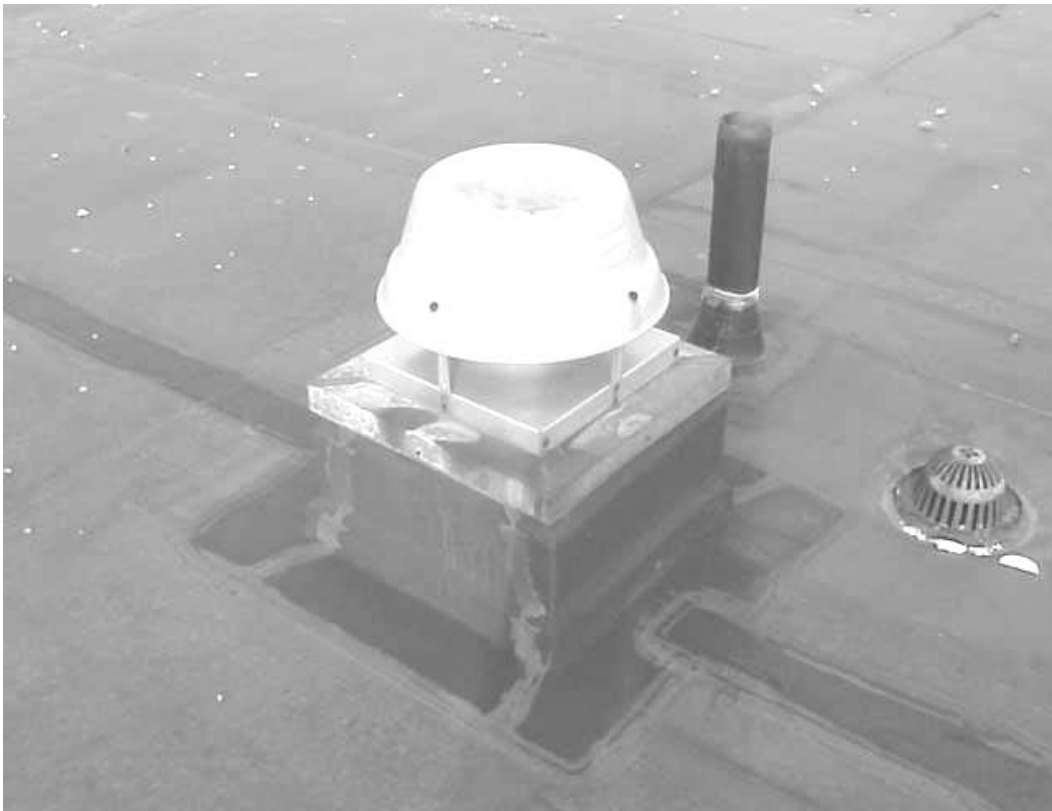
Picture 5

Rooftop Exhaust Motor

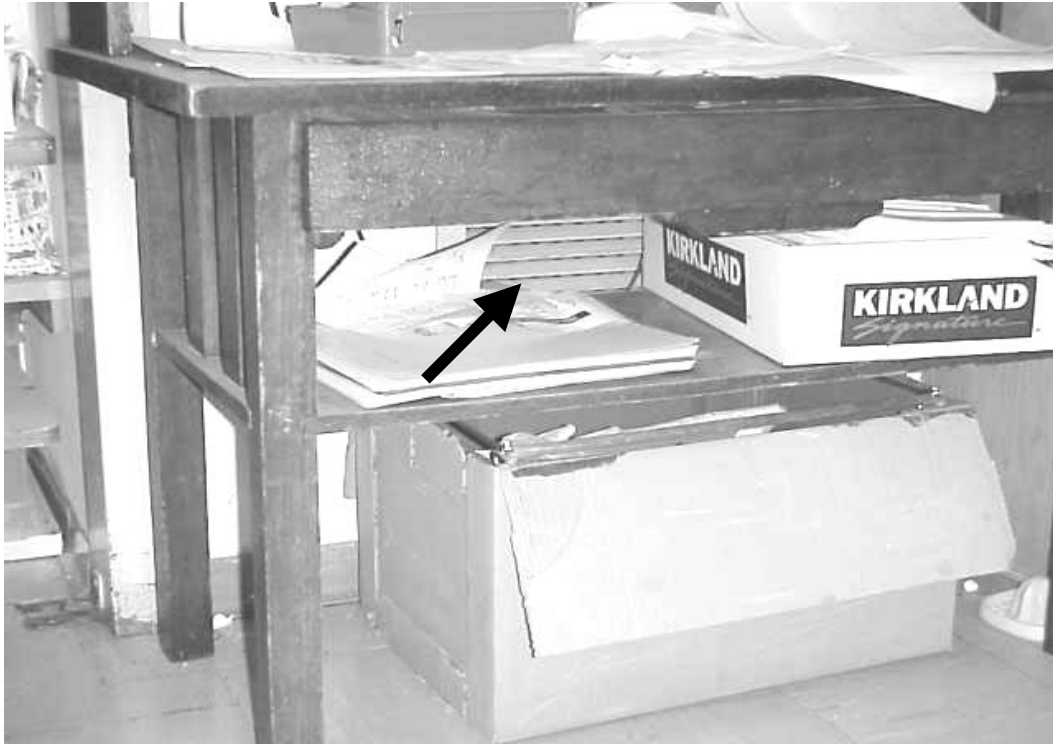
Picture 6

Obstructed Wall-Mounted Exhaust Vent

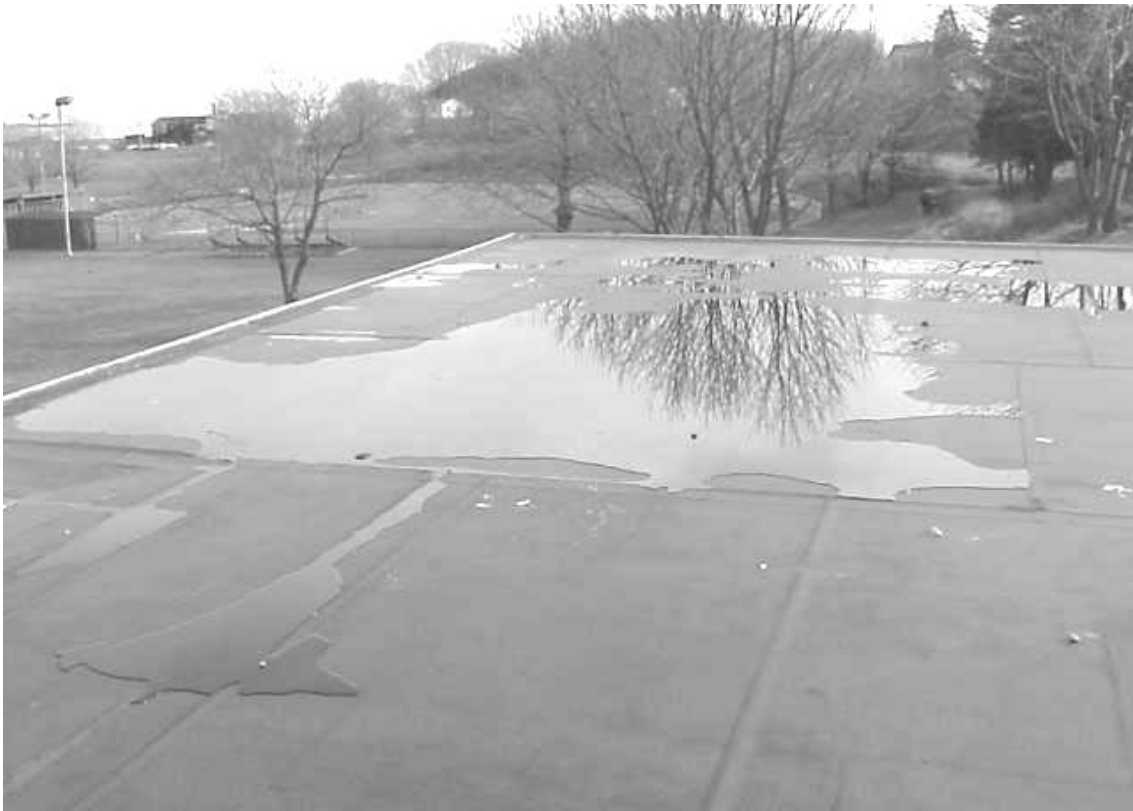
Picture 7

Pooling water was observed in a number of areas on the roof (see Picture 7). The freezing and thawing of water during winter months can lead to roof leaks and subsequent water penetration into the interior of the building. Pooling water can also become stagnant, which can lead to mold and bacterial growth. In addition, stagnant pools of water can serve as a breeding ground for mosquitoes.

Pooling Water on Roof

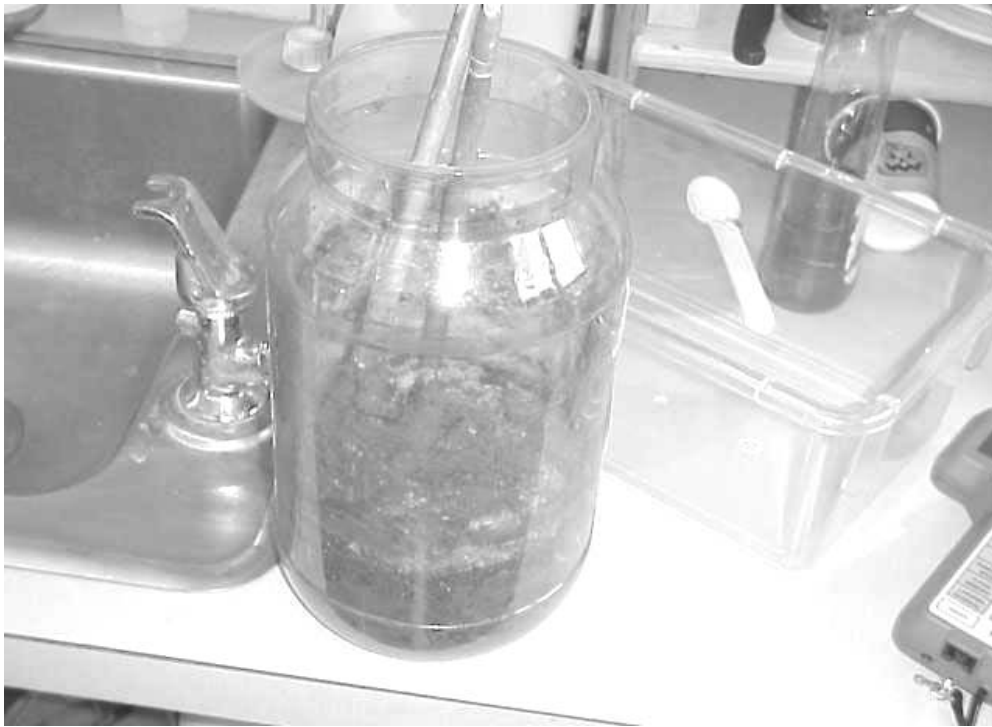
Picture 8

plants in standing water were observed (see Pictures 8 & 9). Moistened plant soil, drip pans and standing water can serve as sources of mold and bacteria growth and be a source of unpleasant odors. Plants should also be located away from univents to prevent the aerosolization of dirt, pollen or mold.

Container of Potting Soil Found beneath Sink in Classroom

9. Move plants away from univents and ensure drip pans are placed underneath plants in classrooms. Examine plants in classrooms for mold growth in water catch basins. Disinfect water catch basins if necessary.

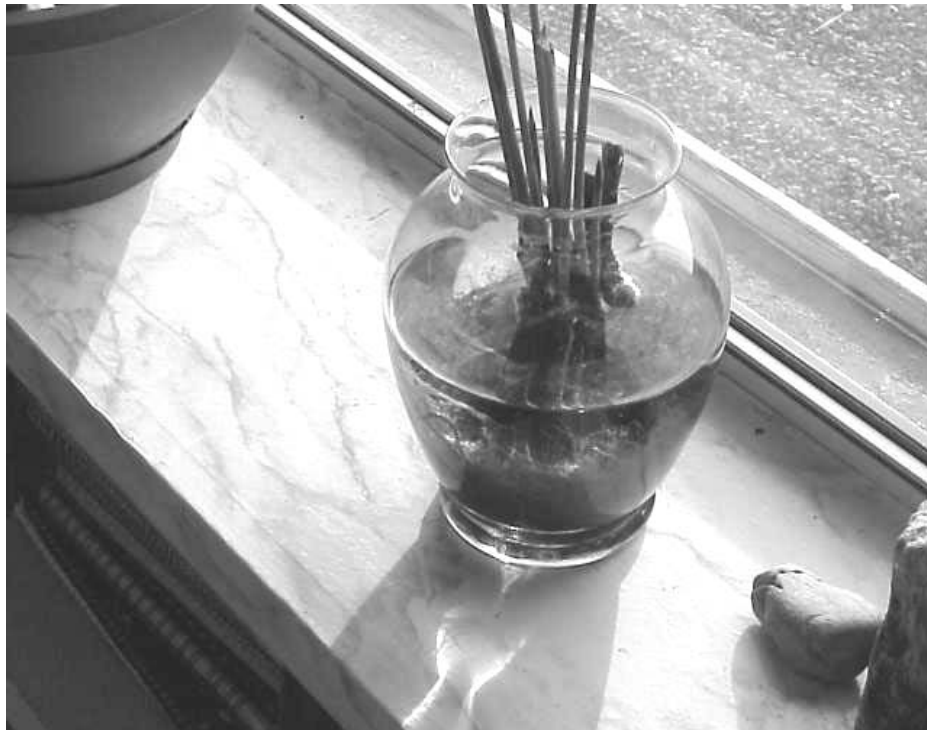
Picture 9

Plant in Standing Water in Classroom

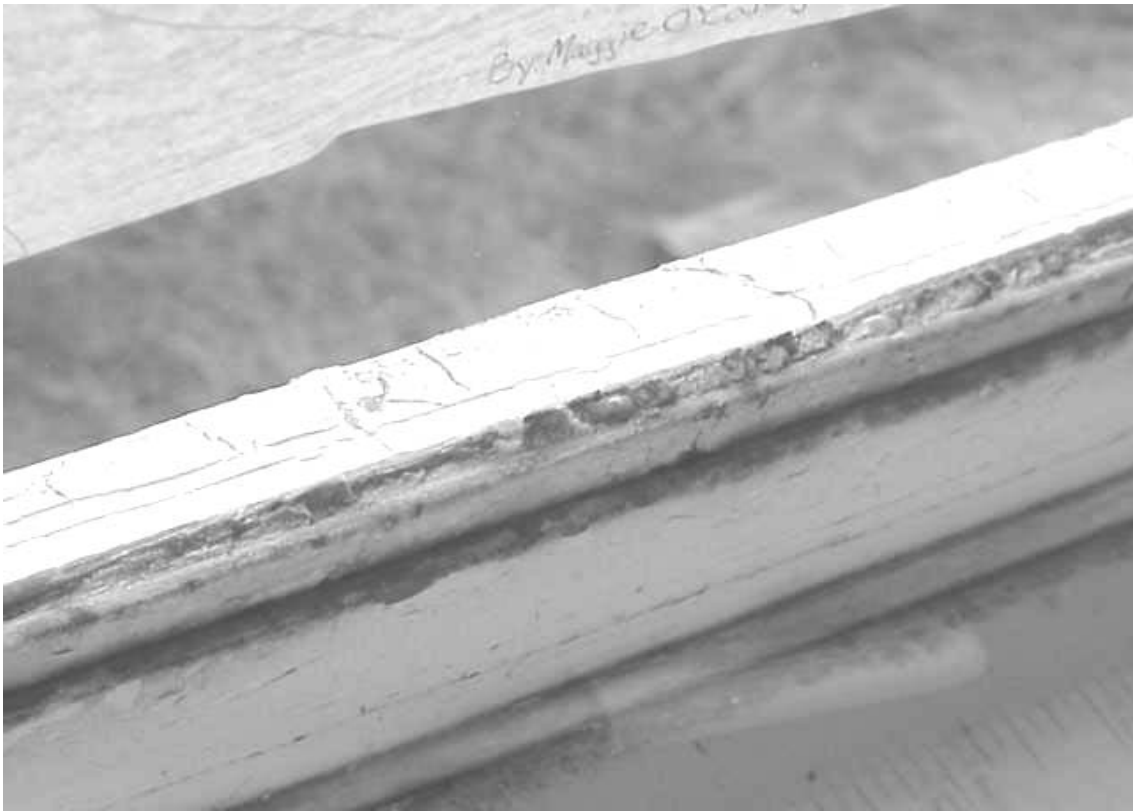
Picture 10

Throughout the school, caulking around the interior and exterior windowpanes was crumbling, missing or damaged (see Picture 10). Repairs of window leaks are necessary to prevent water penetration. Repeated water damage can result in mold colonization of window frames, curtains and items stored on or near windowsills.

Crumbling/Damaged Window Caulking

1. As previously discussed, the age, physical condition and availability of parts for the mechanical ventilation systems throughout the school should be fully evaluated by an HVAC engineering firm to determine the operational lifespan of existing equipment and/or examining the feasibility of replacement.
2. Repair/replace missing or damaged window caulking building-wide to prevent water penetration through window frames.

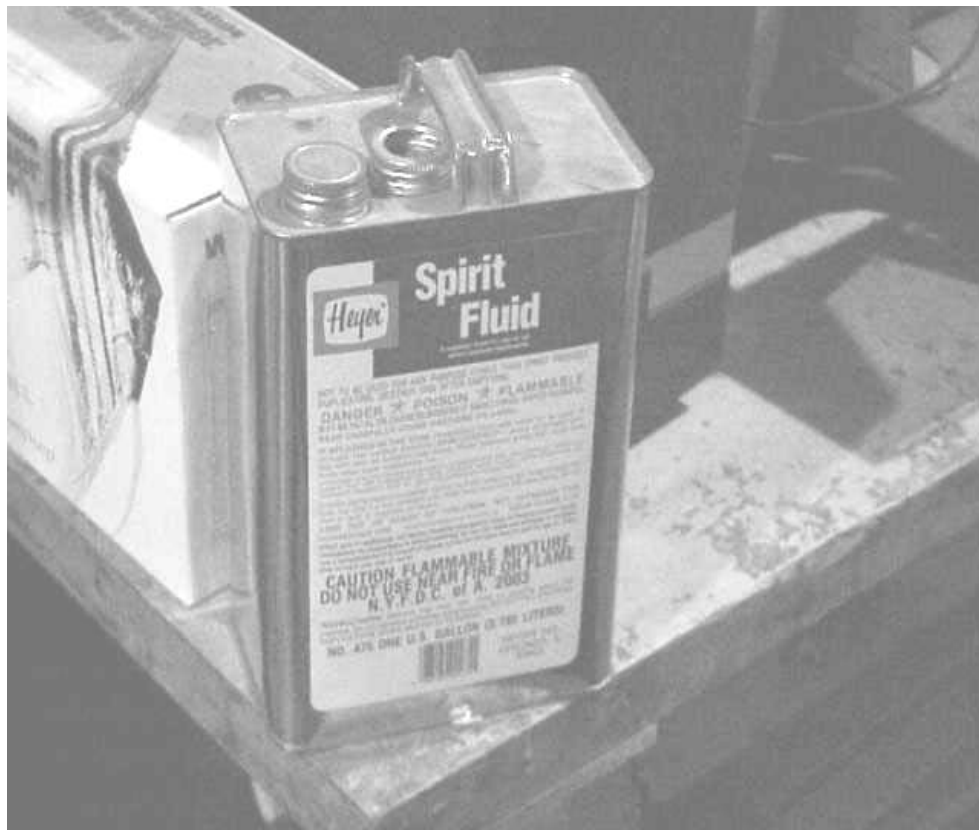
Picture 11

A number of other conditions that can potentially affect indoor air quality were observed. Cleaning products were found on countertops and beneath sinks in a number of classrooms. Cleaning products contain chemicals, which can be irritating to the eyes, nose and throat and should be stored properly and kept out of reach of students. The boiler room hallway, which is used for storage, contained a mimeograph machine and containers of duplicating fluid (see Picture 11). Mimeograph duplicating fluid contains methanol (methyl alcohol), which is a volatile organic compound (VOC) that readily evaporates at room temperature. The off gassing of this material can be irritating to the eyes, nose and

Container of Duplicating Fluid

15. Store flammable materials in flameproof cabinets in a manner consistent with state and local fire codes.
16. Refrain from using strong scented materials in classrooms and restrooms.

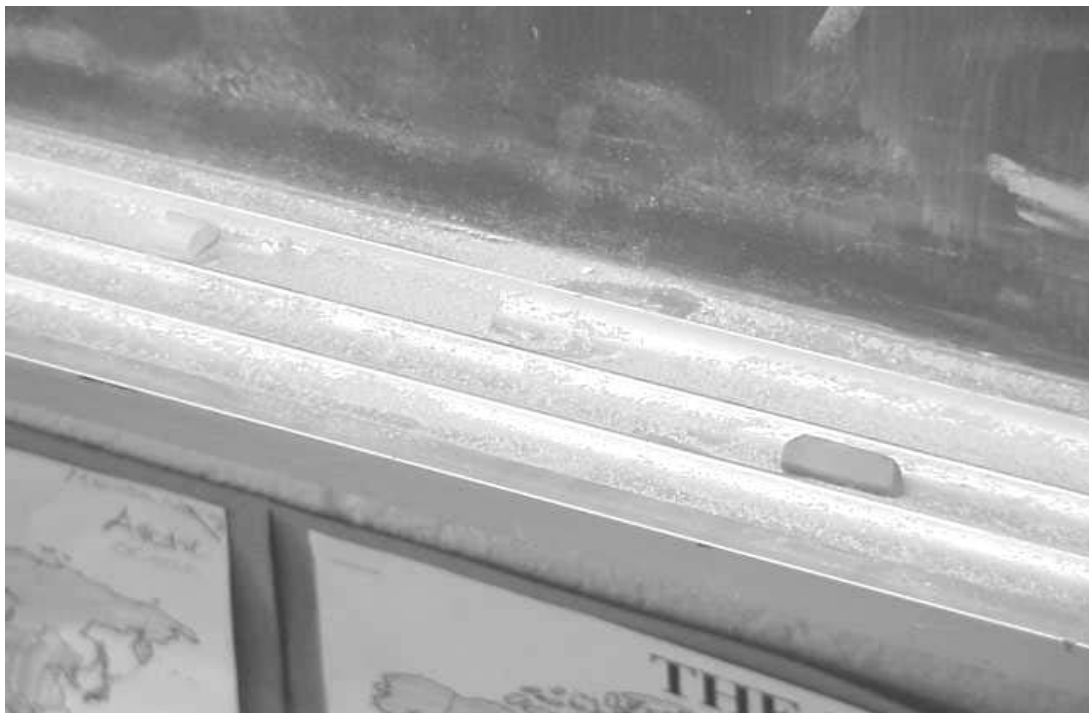
Picture 12

Several classrooms contained dry erase boards and dry erase markers. Materials such as dry erase markers and dry erase board cleaners may contain VOCs, (e.g., methyl isobutyl ketone, n-butyl acetate and butyl-cellusolve) (Sanford, 1999), which can be irritating to the eyes, nose and throat. Accumulated chalk dust was noted in several classrooms (see Picture 12). Chalk dust is a fine particulate, which can be easily aerosolized and is an eye and respiratory irritant. Several areas had missing ceiling tiles. Missing ceiling tiles can provide an egress for dirt, dust and particulate matter into occupied areas. These materials can also be irritating for certain individuals.

Accumulated Chalk Dust in Classroom

13. Clean chalkboards and chalktrays regularly to prevent the build-up of excessive chalk dust.
14. Encapsulate damaged/exposed fiberglass in former kitchen area and in the 1964-addition hallway.

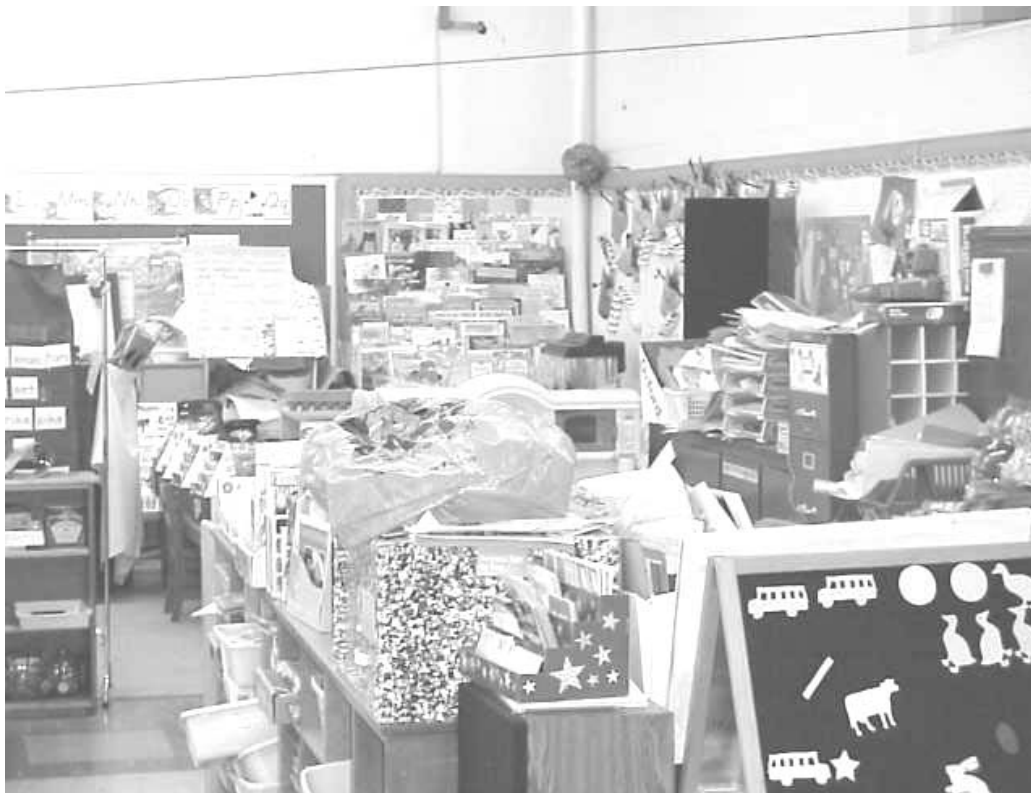
Picture 13

Also of note was the amount of materials stored inside classrooms (see Picture 13). Items were seen piled on windowsills, tabletops, counters, bookcases and desks in classrooms throughout the school. The large amount of items stored allows for dusts and dirt to accumulate. These stored items, (e.g., papers, folders, boxes) make it difficult for custodial staff to clean. Dust can be irritating to the eyes, nose and respiratory tract.

Accumulated Items in Classroom

8. Relocate or consider reducing the amount of materials stored in classrooms to allow for more thorough cleaning. Clean items regularly with a wet cloth or sponge to prevent excessive dust build-up.

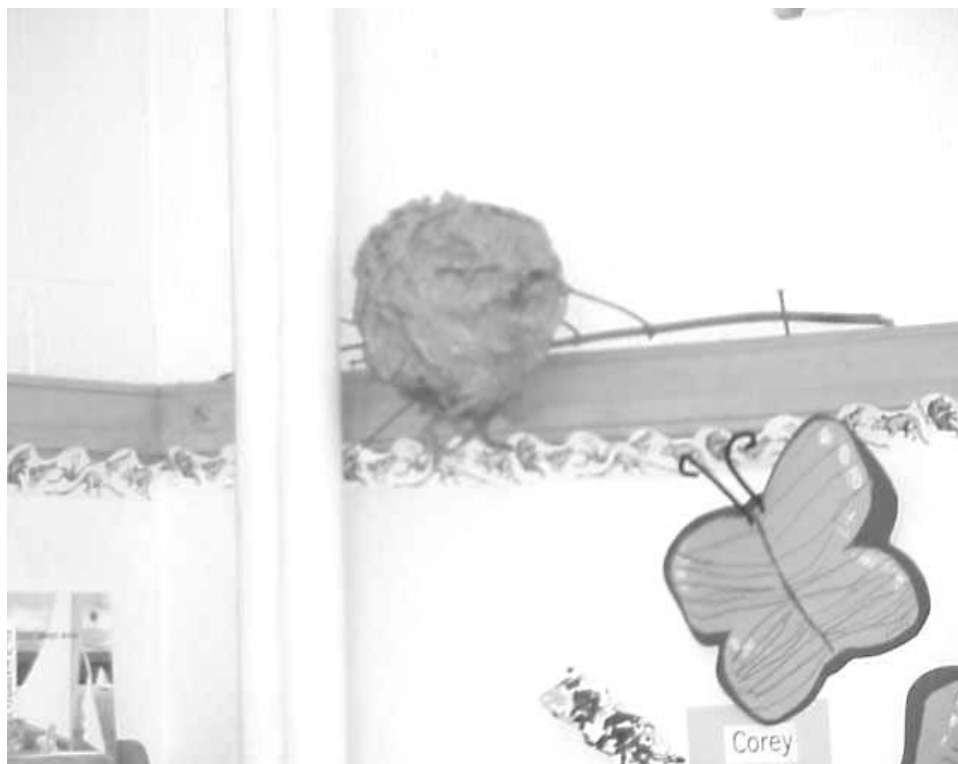
Picture 14

A wasp's nest was displayed in one classroom, which serves as a learning tool (see Picture 14). Insect parts can become dried out and aerosolized and may serve as a source of allergenic material for sensitive individuals. Exposed fiberglass insulation was noted in the former kitchen area and in the hallway around pipes in the 1964 addition (see Picture 15). If damaged, fiberglass insulation material can release fibers and be a source of skin, eye and respiratory irritation.

Hornet/Wasp's Nest in Classroom

11. Store chemicals and cleaning products properly and out of the reach of students.
12. Consider bringing in wasps' nest on an "as needed" basis to prevent exposure to potentially allergenic materials.

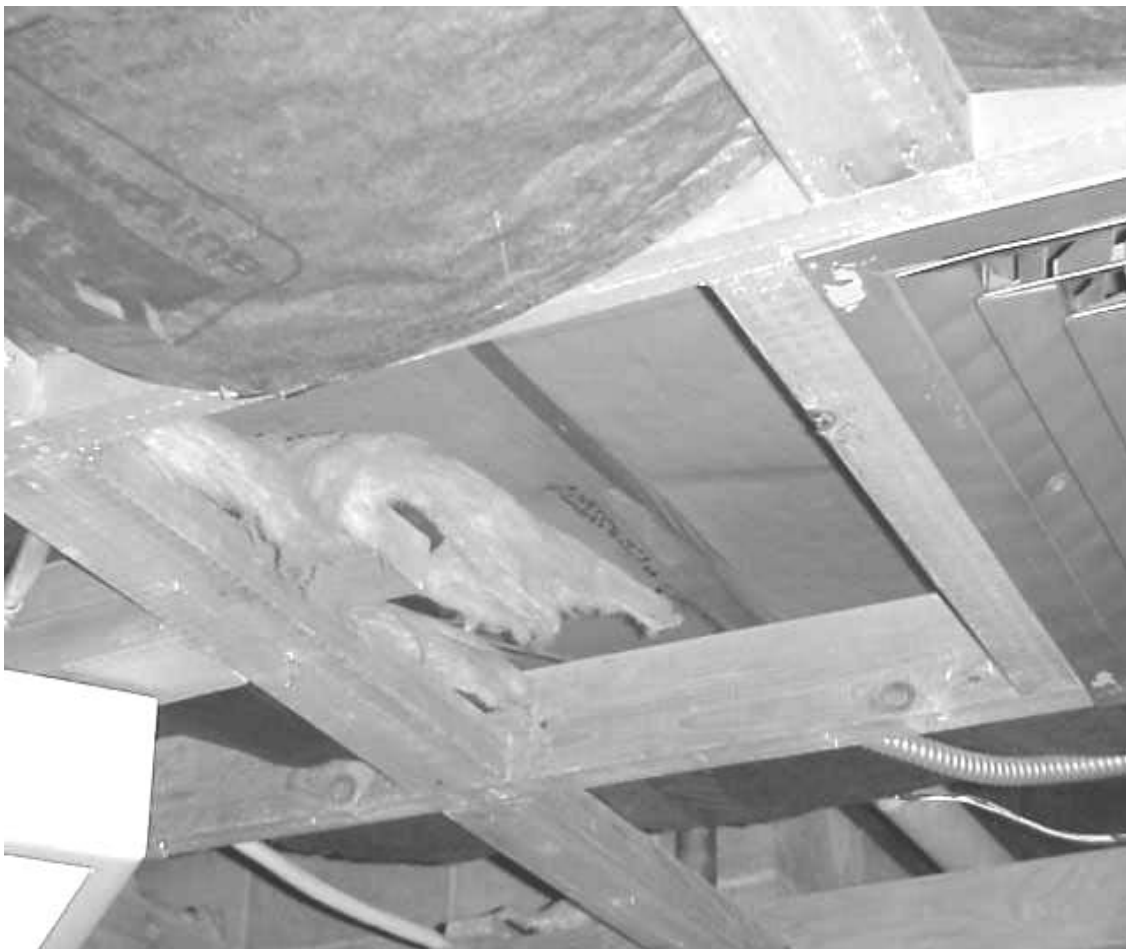
Picture 15

Exposed Fiberglass Insulation in Former Kitchen Area
